Technical Report HL-96-22
December 1996

Demonstration Erosion Control Project Monitoring Program

Fiscal Year 1994 Report

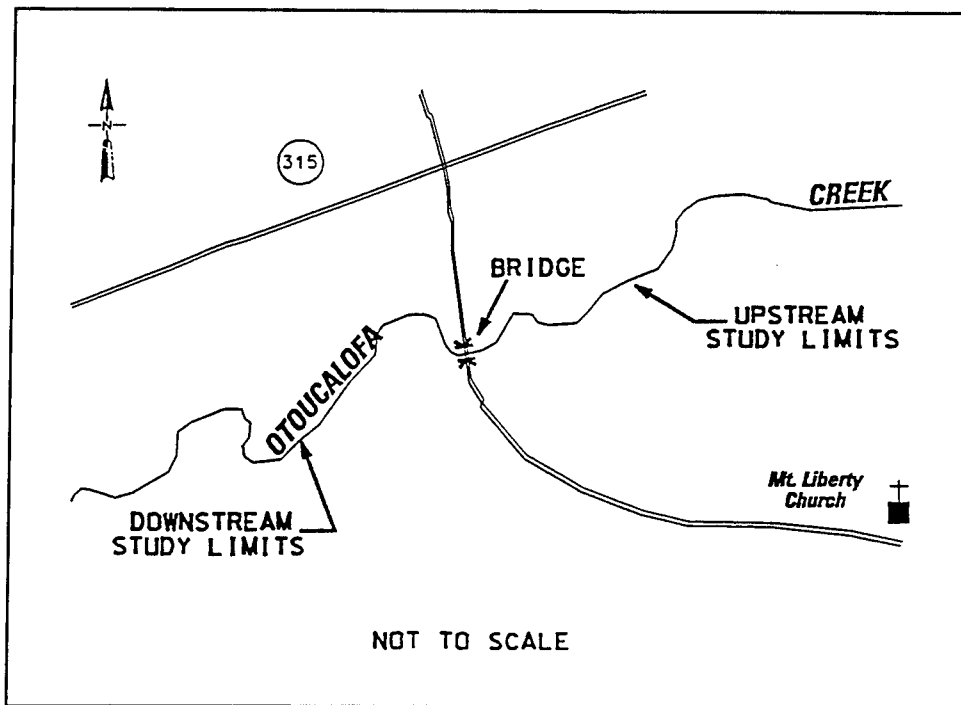
Figure 36. Otoucalofa Creek, Site 14

Site 14 is on Otocalofa Creek, east of Water Valley, MS. The study reach is 4,000 ft in length, 2,000 ft upstream and downstream of the Mt. Liberty Church road bridge, in T11S, R3W, Sections 4 and 5, of the Water Valley quadrangle map (Figure 36). The watershed area at the site is approximately 41 square miles.

Presently, only riprap dikes and longitudinal dikes are constructed throughout the reach; however, a low-drop structure is proposed for the future. The reach was observed to be actively incising, and this incision is occurring at an elevation below the recently placed stone. This site provides a unique opportunity to observe the riprap subjected to degradation.

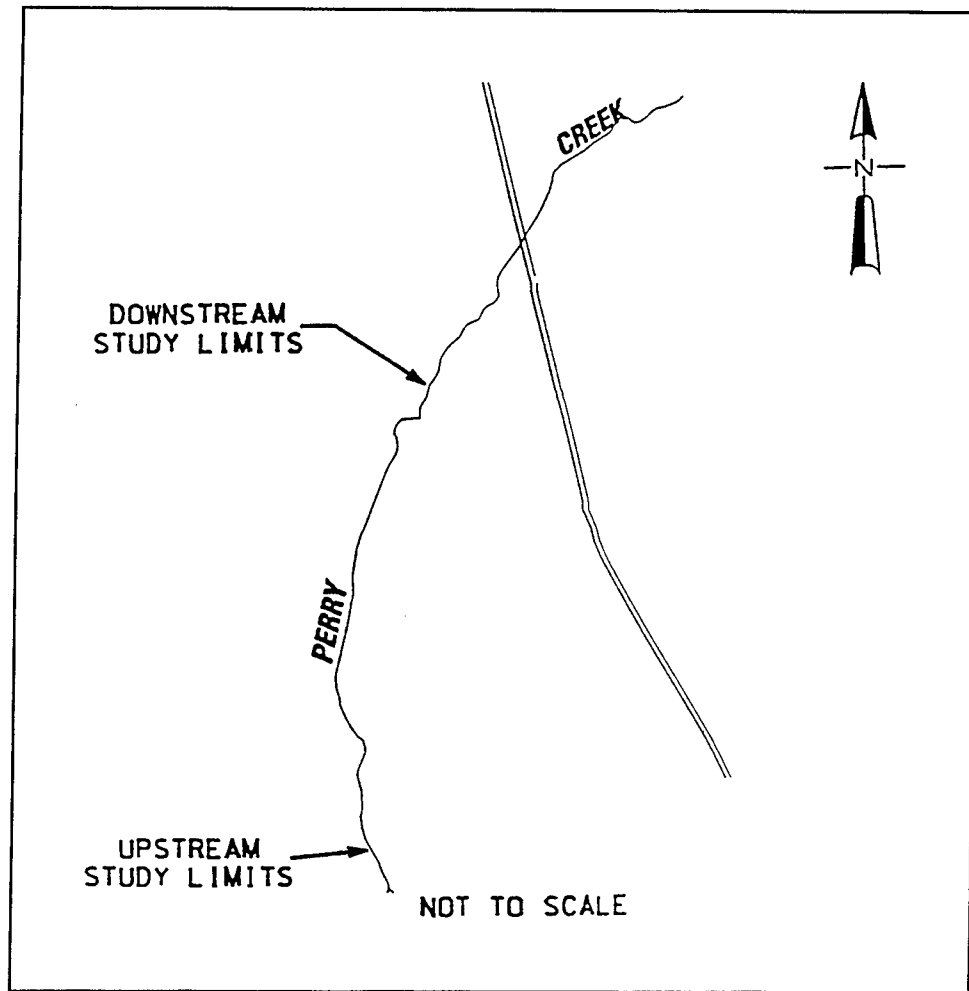
Figure 38. Perry Creek, Site 16

Site 16 is located on Perry Creek as shown in Figure 38. The study reach begins approximately at the T21N, R4E, Section 1, northern line and continues upstream through Sections 2 and 11. The study reach is located on the McCarley quadrangle map. The entire study reach length is approximately 2 miles. Four low-drop structures were completed during 1994. This site will allow the investigation of the effects of four structures in series. The site is unique because within the study reach, the channel moves from a deeply incised stream at the downstream end to a stream that might have existed prior to channelization at the upstream end. Plans are to gauge the stream at the I-55 box culvert downstream of the study reach.

Field inspection in October 1994 indicates that vegetation density is increasing along the study reach and that the beavers have constructed numerous dams. Gullyng was noted within the construction area and downstream of the

left bank riprap at the third structure. This gully enters the channel in the toe riprap. Another gully, which should be considered for a drop pipe, is present on the right bank downstream of the left bank existing pond and drop pipe, approximately adjacent to the power pole in the open field. The bed of the channel is very steep upstream of the third structure and composed of fractured ironstone and clay. Upstream of the fourth structure and within the construction clearing on the left bank is a severe gully that requires attention. In general, the structures are performing well and the system seems to be stabilized; however, specific sites need attention.

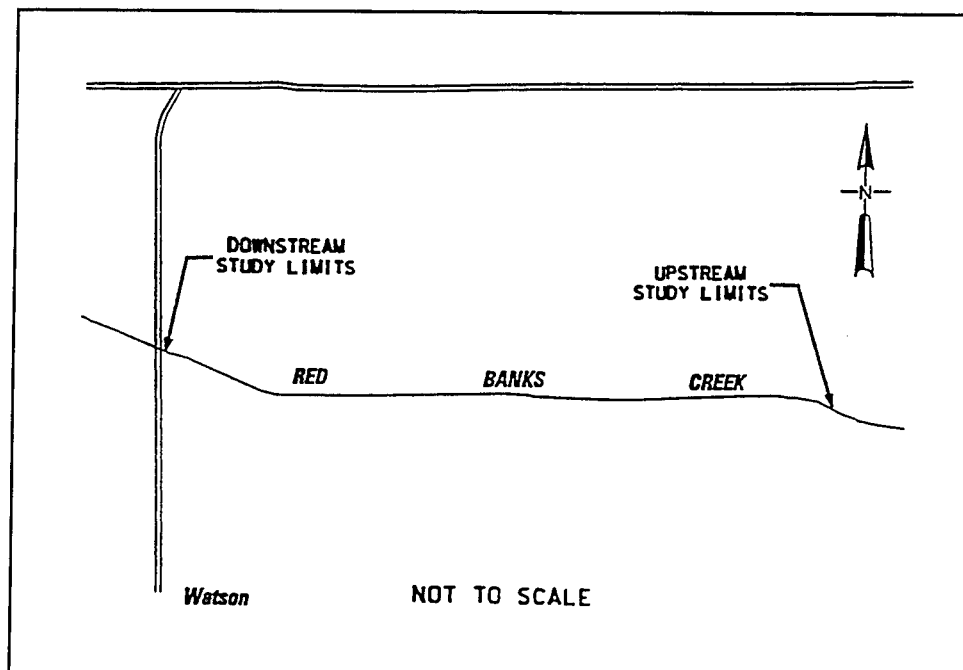
Figure 40. Red Banks Creek, Site 9

Site 9 is located on Red Banks Creek in the Coldwater River basin (Figure 40). The study reach extends approximately 2.5 miles upstream from the bridge on the county road between the communities of Warsaw and Watson, MS. This site can be located on the Byhalia quadrangle map, T3S, R5W, Section 24, and R4W, Sections 19 and 20, and has a watershed area of approximately 28 square miles. The bed sediment load is sand, and the stream flows in a deeply incised and widened, straight channel that is the consequence

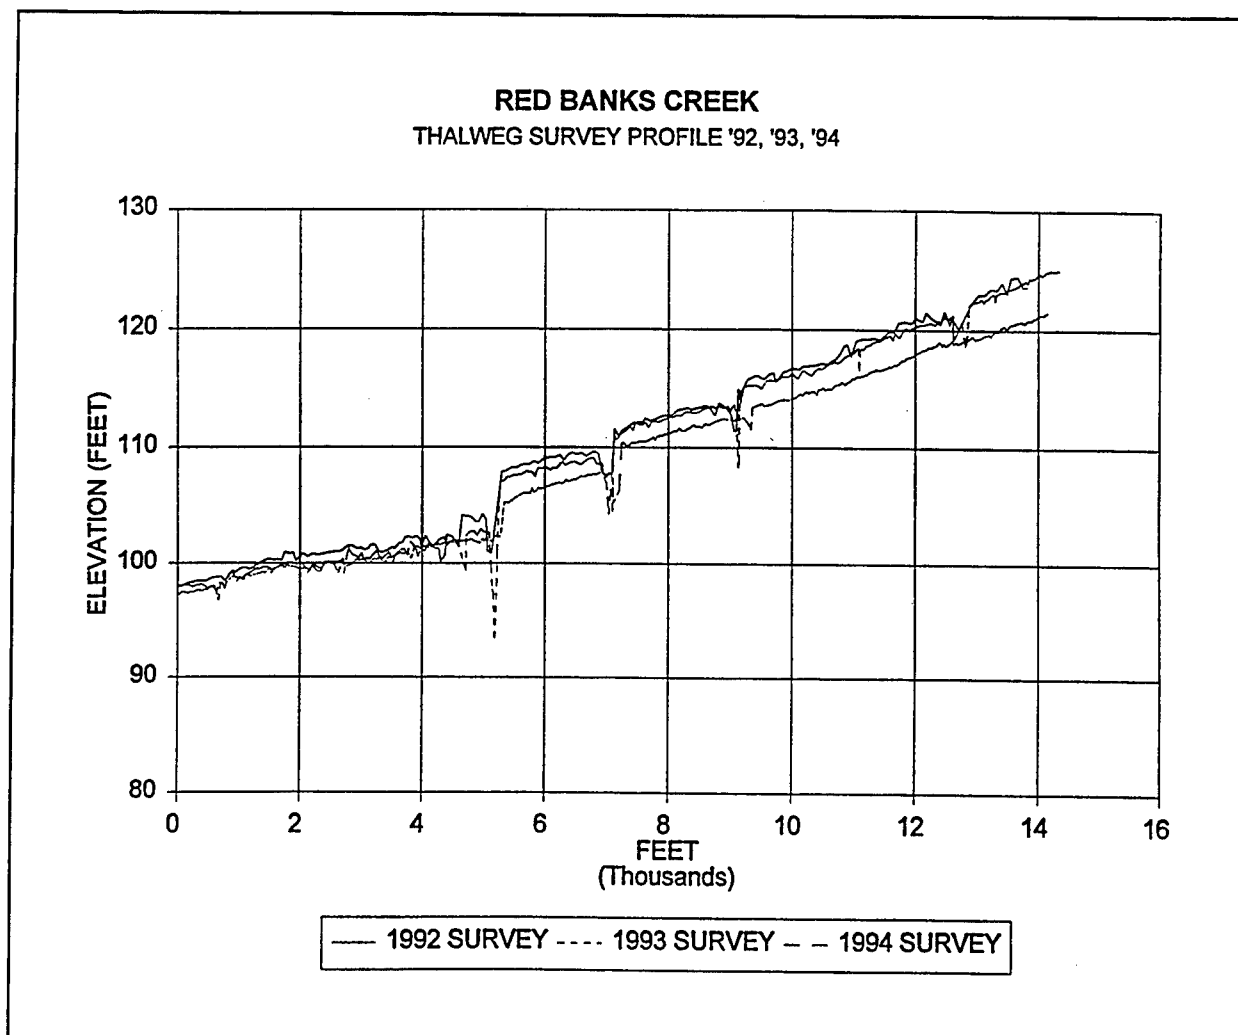
Figure 41. Red Banks Creek, Site 9, thalweg profile

As shown in the accompanying thalweg profile (Figure 41), Red Banks Creek has been dynamic during the 1992 to 1994 study period. Prior to 1992, 2 tons per linear foot longitudinal riprap and four riprap chevron weirs were placed in the study reach. The channel was narrowed significantly at the downstream bridge and immediately upstream of the bridge for a distance of approximately 100 ft. Degradation in the range of from 1 to 3 ft is shown from 1992 to 1993 and to 1994 downstream of the chevron weirs. Approximately at station 50+00 a headcut was observed in 1992 and 1993. The pool downstream of the most downstream chevron weir was surveyed to be in excess of 10 ft in depth and increased in depth during the 1992 and 1993 period. During the 1994 thalweg survey, degradation had occurred and the riprap of this

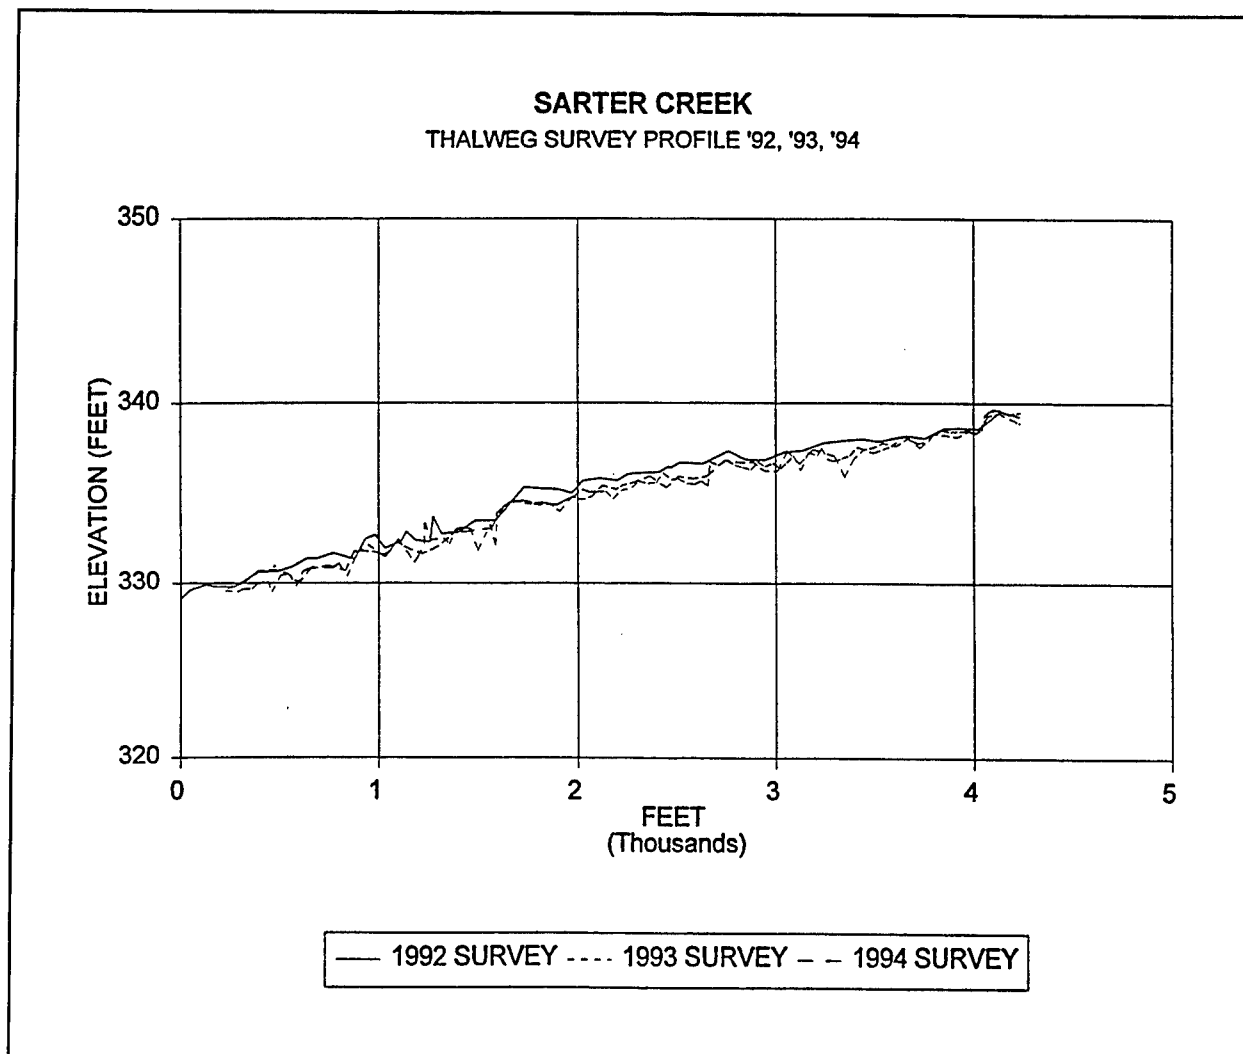
Figure 43. Sarter Creek, Site 15, thalweg profile

BURBANK analyses indicate that the banks are not yet geotechnically unstable (Table 23). The SAM analyses indicated that the average width and

slope are remaining constant at about 117 percent of the width and 170 percent of the slope required for minimum stream power for the transport of 1,000 mg/l.

In general the bank stability remains good because the bank height is low, but the degradation potential is high. The channel is relatively small, only about 30 ft in width, and consideration should be given to testing lower cost grade control structures, such as gabion structures, to stabilize the channel.

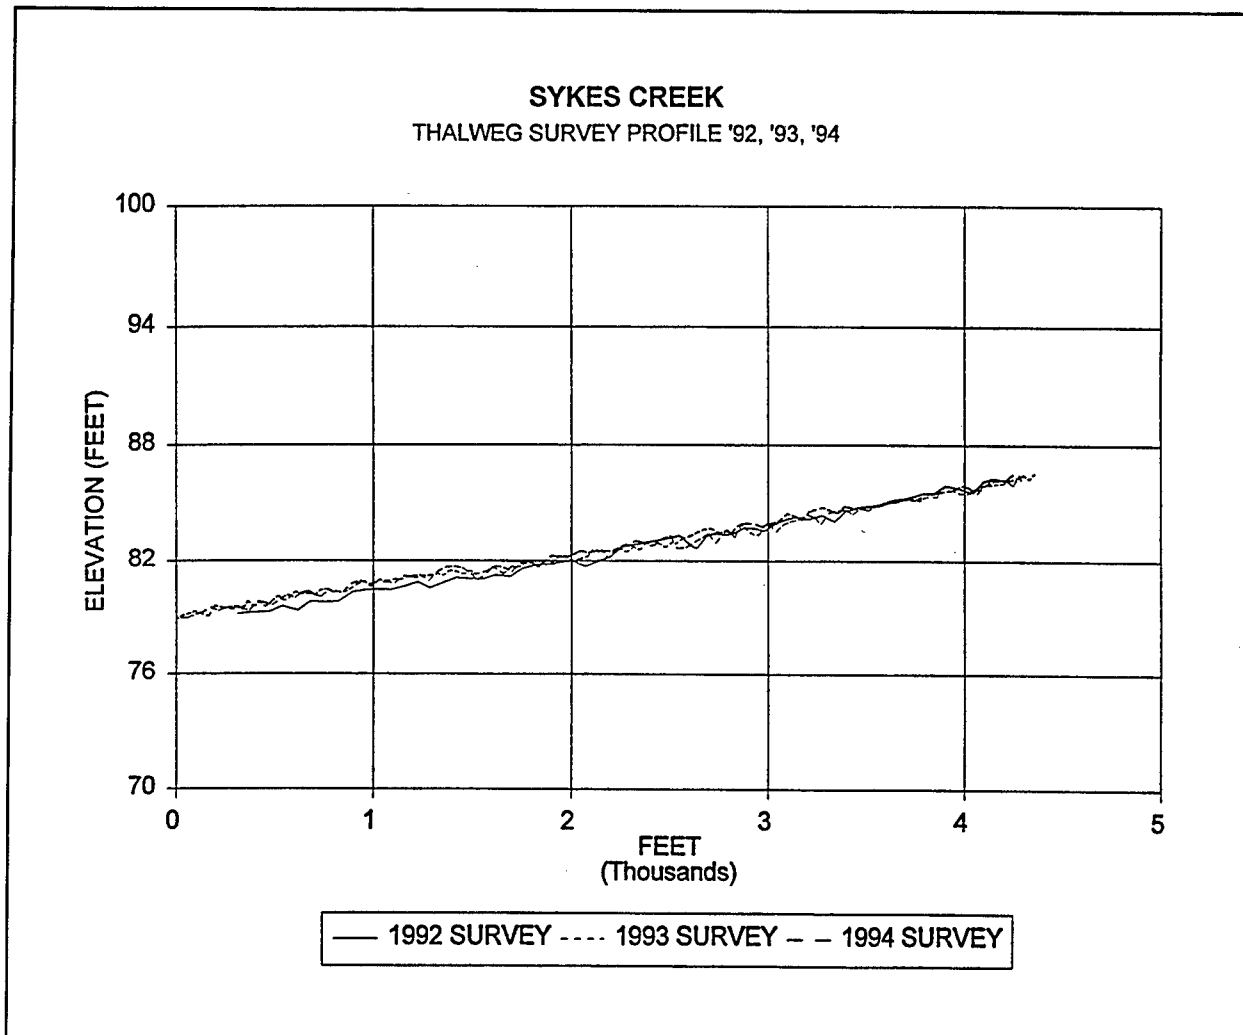
Figure 45. Sykes Creek, Site 17, thalweg profile

The accompanying thalweg profile (Figure 45) indicates that little change has occurred during the 3-year period. Several factors relative to the site, such as berm formation, depth of sand in the bed, and thalweg comparison, indicate that the channel could be considered in quasi-equilibrium. However, comparison of the existing conditions with the slope and width required at minimum stream power for transport of 1,000 mg/l indicates that the reach is transporting a relatively high sediment load. Based on the 1994, 2-year flow, the water surface slope is 235 percent of the minimum slope and the width is 70 percent of the width at minimum slope (Table 24). Also, the BURBANK analyses indicated that approximately 40 percent of the channel banks are unstable if degradation of 1 ft or more occurs.

About 300 ft upstream of the county road bridge a large, tight bend is active and in the process of producing a channel cutoff. During the present monitoring program the point bar chute has progressively enlarged, and the upstream approach has become more abrupt. At the same time the old channel has become increasingly choked by debris. Presently the upstream approach bend is eroding heavily into a residential lot, and, following the cutoff, the banks adjacent to a downstream hayfield will probably erode. The alignment to the downstream bridge is presently relatively straight, and the new alignment is uncertain. The cutoff will increase the slope locally and may cause upstream

degradation. To fully evaluate the short- and long-term impacts of the changes occurring in this reach, consideration should be given to identification of upstream sediment sources, remedial measures to reduce sediment supply, possible future grade control, reduction of the slope and the bank height, and attention to the bridge alignment.

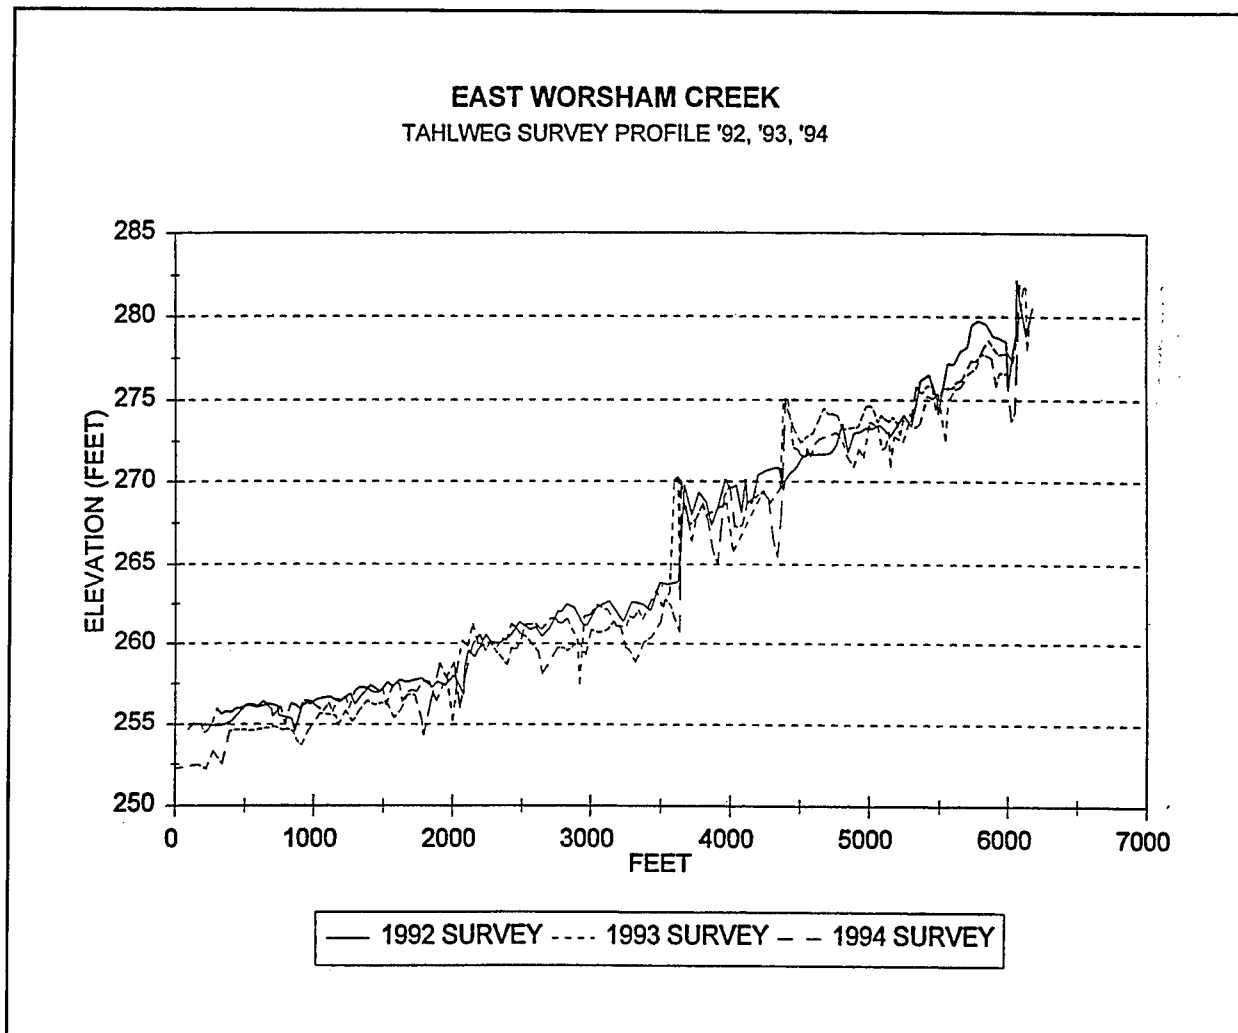
Figure 47. East Worsham Creek, Site 18a, thalweg profile

The downstream extent of the reach defined as East Worsham Creek (Site 18a) is the confluence of Worsham Creek with Middle Worsham, which is the first confluence downstream of the highway bridge. The thalweg profile indicates the locations of the structures and the variations in the profile indicating a general tendency for this site to degrade over the present monitoring program (Figure 47).

The reach is divided into three segments. Segment 1 extends upstream from the confluence to the downstream, older structure. The short reach between the two structures was not analyzed separately. Segment 3 is upstream of the middle structure. A beneficial effect of the upstream grade control structures can be realized by comparing the percentage of bank at risk for the zero friction angle condition in 1994 (Table 25). Grade control has raised the channel bed to reduce the percentage of unstable bank from 98 percent in segment 1 to 0 percent in segment 3. This is a significant improvement. However, the 2-year slope in both segments remains very high at approximately 300 percent of the 1000-mg/l minimum slope. Fortunately, the segment 3 bed is composed primarily of very erosion resistant clay, and segment 1 includes numerous outcrops of ironstone and clay that provide a degree of vertical stability. Sediment transport in both segments is significantly controlled at lower discharges by beaver dams. The durability of the beaver

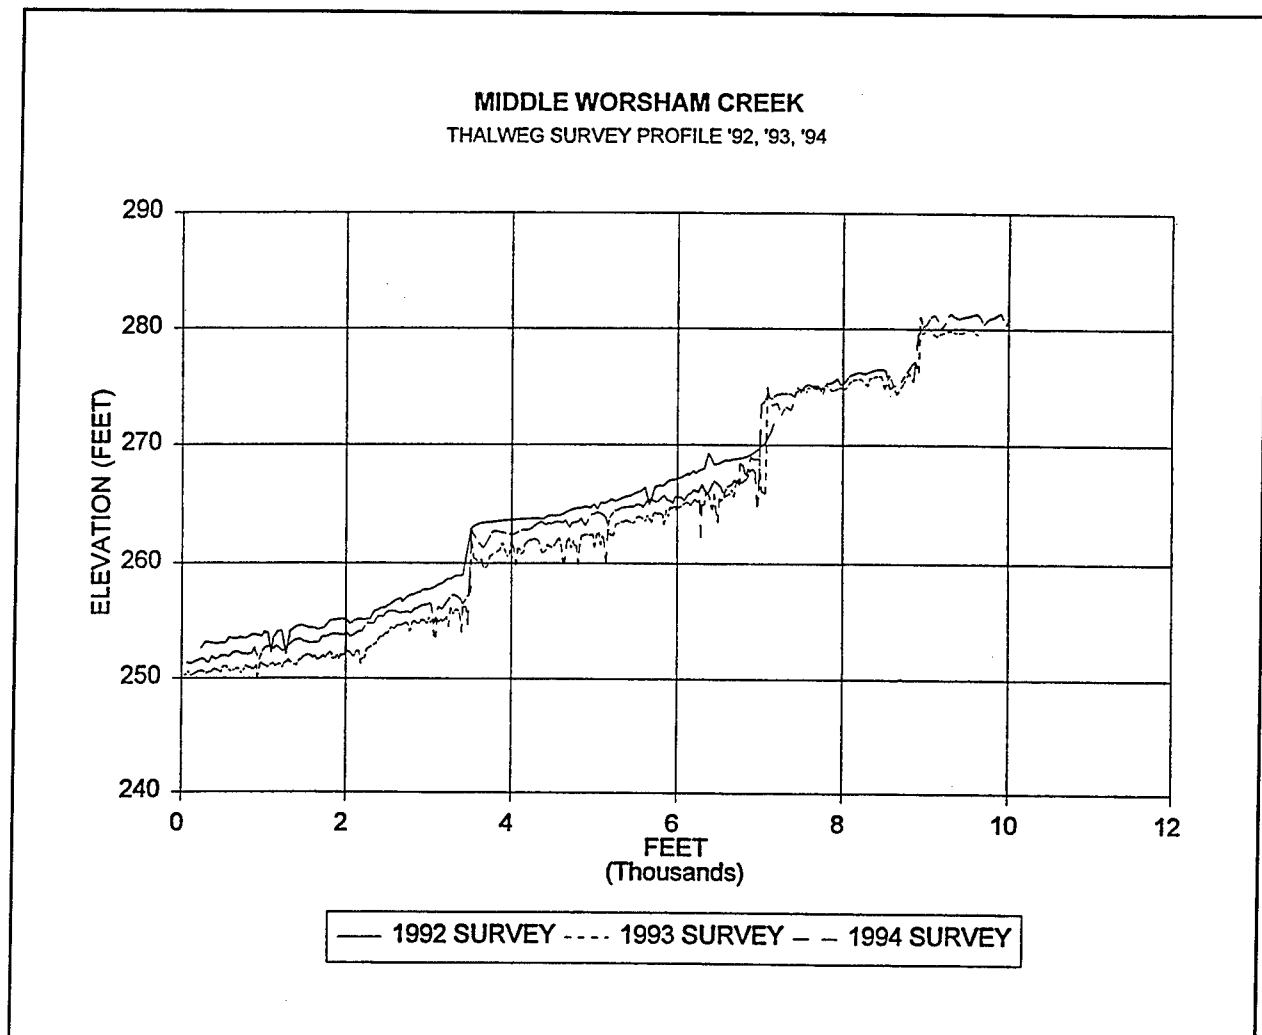
Figure 48. Middle Worsham Creek, Site 18b, thalweg profile

The downstream extent of Middle Worsham is at the confluence of Worsham Creek with West Worsham Creek. The total reach is approximately 10,000 ft in length and is divided into four reaches by three ARS-type, low-drop structures. The accompanying thalweg profile (Figure 48) depicts the degradation that has occurred since 1992 in the lower two segments. Immediately upstream of the confluence of West and Middle Worsham, segment 1 has a shallow depth of sand, less than 2 ft, for most of the segment to the confluence with East Worsham. Upstream of this confluence, the channel is narrower and knick zones are present. Two drop pipes had been cleared for surveying in this reach. In segment 2, as the upstream structure is approached,

knick zones and massive bank failures are present. The gully of the left bank downstream of the newer structure has been rehabilitated, and the structure has resulted in channel aggradation upstream to the channel ford, which is immediately downstream of the third structure. Headcutting upstream of this point is moving into the older structure slowly, and the upstream structure basin has significant sand deposits and willow growth. Upstream of the third structure, knickpoints are present at several locations. The right bank is eroding and consideration should be given to fencing the right bank upstream of the third structure to limit cattle access. Some form of grade control may be appropriate in the upper segment.

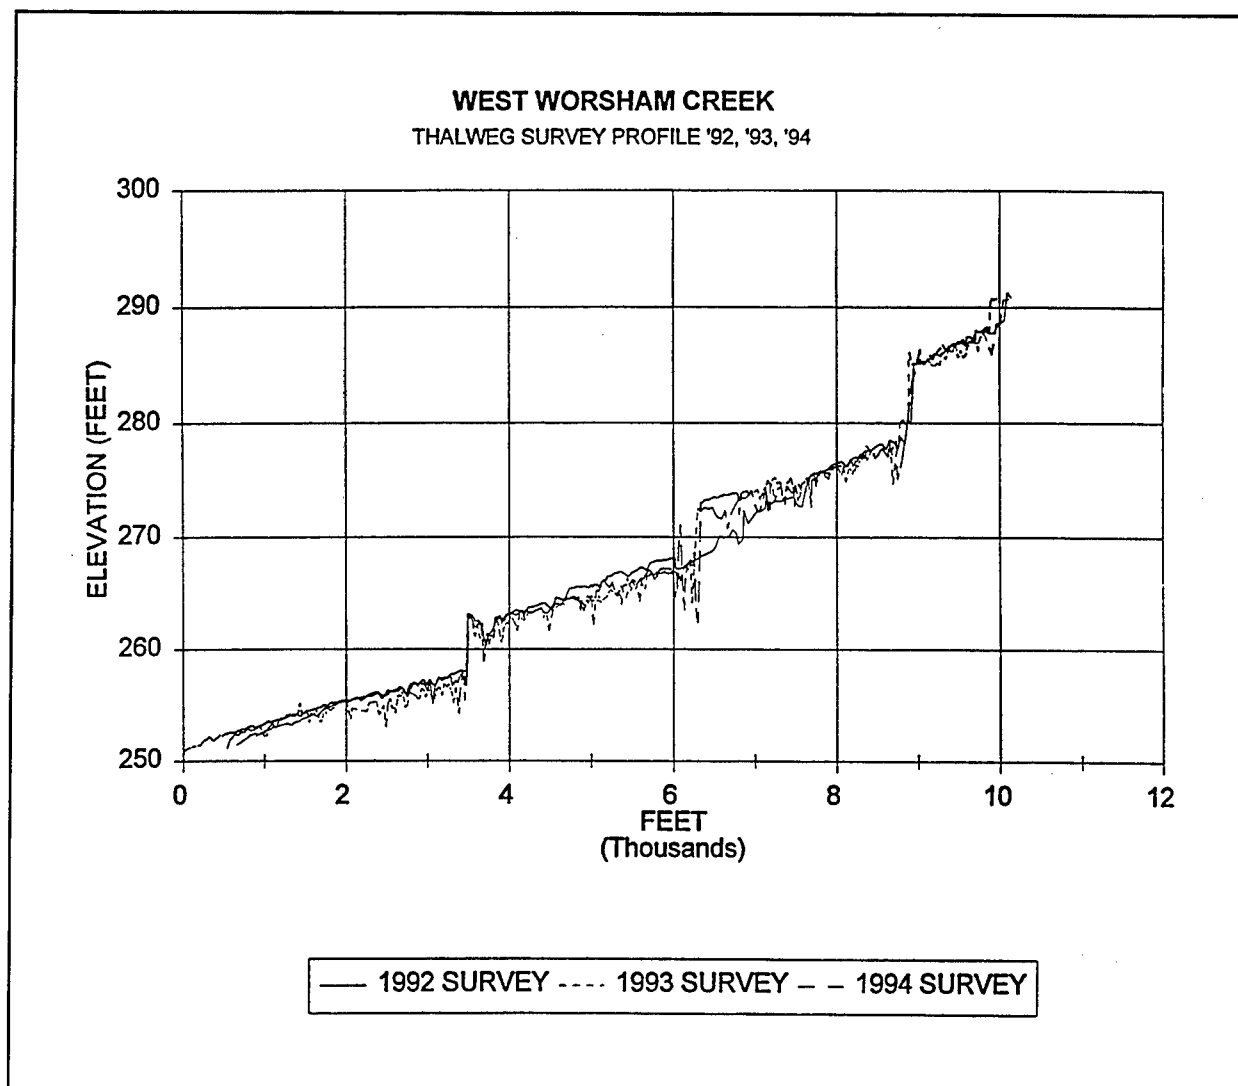
Figure 49. West Worsham Creek, Site 18c, thalweg profile

The total reach length is approximately 10,000 ft and is divided into four segments by three ARS-type, low-drop structures. The thalweg profiles (Figure 49) indicate some degradation in the lower two segments, and clearly indicate that the aggradation has occurred immediately upstream of the newer structure. Note that the 1994 profile indicates filling to the weir crest of the newer, second structure, while the older, first structure has not filled. This indicates that the improved hydraulic control of the newer design results in improved performance, and suggests that renovation to improve hydraulic control is worth consideration. It should be noted that beaver dams are abundant immediately downstream of the first structure and upstream of the second structure. The gully into the second structure has been rehabilitated, and clearing has been accomplished for work at the downstream right bank gully within that site.

The BURBANK results indicate that banks are relatively stable, except in the lower segment (Table 27). This was confirmed by field inspection in October 1994. The 2-year water surface slope of the reach averages 315 percent, and the average stream width averages 63 percent of the slope and width required at minimum stream power for transport of 1,000 mg/l. Although these data indicate a relatively unstable, incising channel, significant grade control has been placed in the system. The newer, second structure in segment 3 has been very effective in reducing slope, from 557 percent to 218 percent of the slope at minimum stream power for transport of 1,000 mg/l. Consideration should be given to adding grade control downstream of the confluence of West and Middle Worsham Creeks.

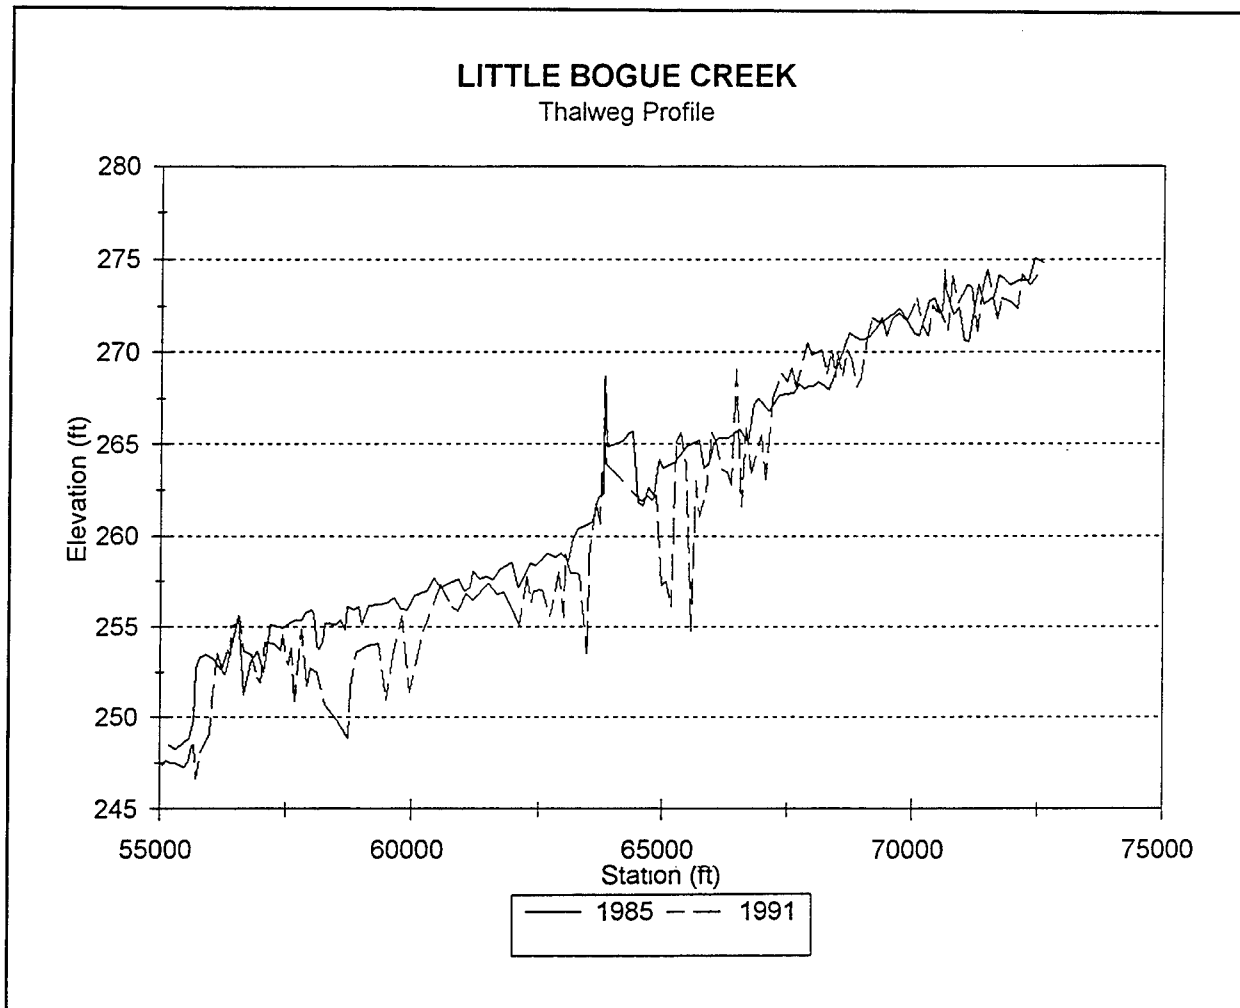
Figure 59. Comparison of 1985 and 1991 thalweg profiles

The thalweg profile (Figure 59) indicates that the bed has degraded between stations 570+00 and 625+00 during the period between 1985 and 1991. This may have been influenced by construction of the upstream grade control. The 1995 data indicate that changes between 1991 and 1995 were minor in the reach immediately downstream of the structure. Upstream of the structure some filling is noted; however, the bed remains below the original weir elevation for a distance of approximately 3,000 ft. Recent reconstruction of the

structure should improve upstream aggradation, and may have filled some of the deeper features immediately downstream of the structure. The slopes for the three channel reaches are listed in the accompanying tabulation.

appearance upstream, with some berming along the toe of the bank and with more permanent vegetation. In this reach the riprap is resting on the upper surface of the shale outcrop, and the shale has been eroded approximately 3 ft vertically. Launched riprap does not remain on the shale surface and is transported downstream. As shown in the thalweg profile (Figure 59), the water depth upstream of the outcrop is relatively deep.

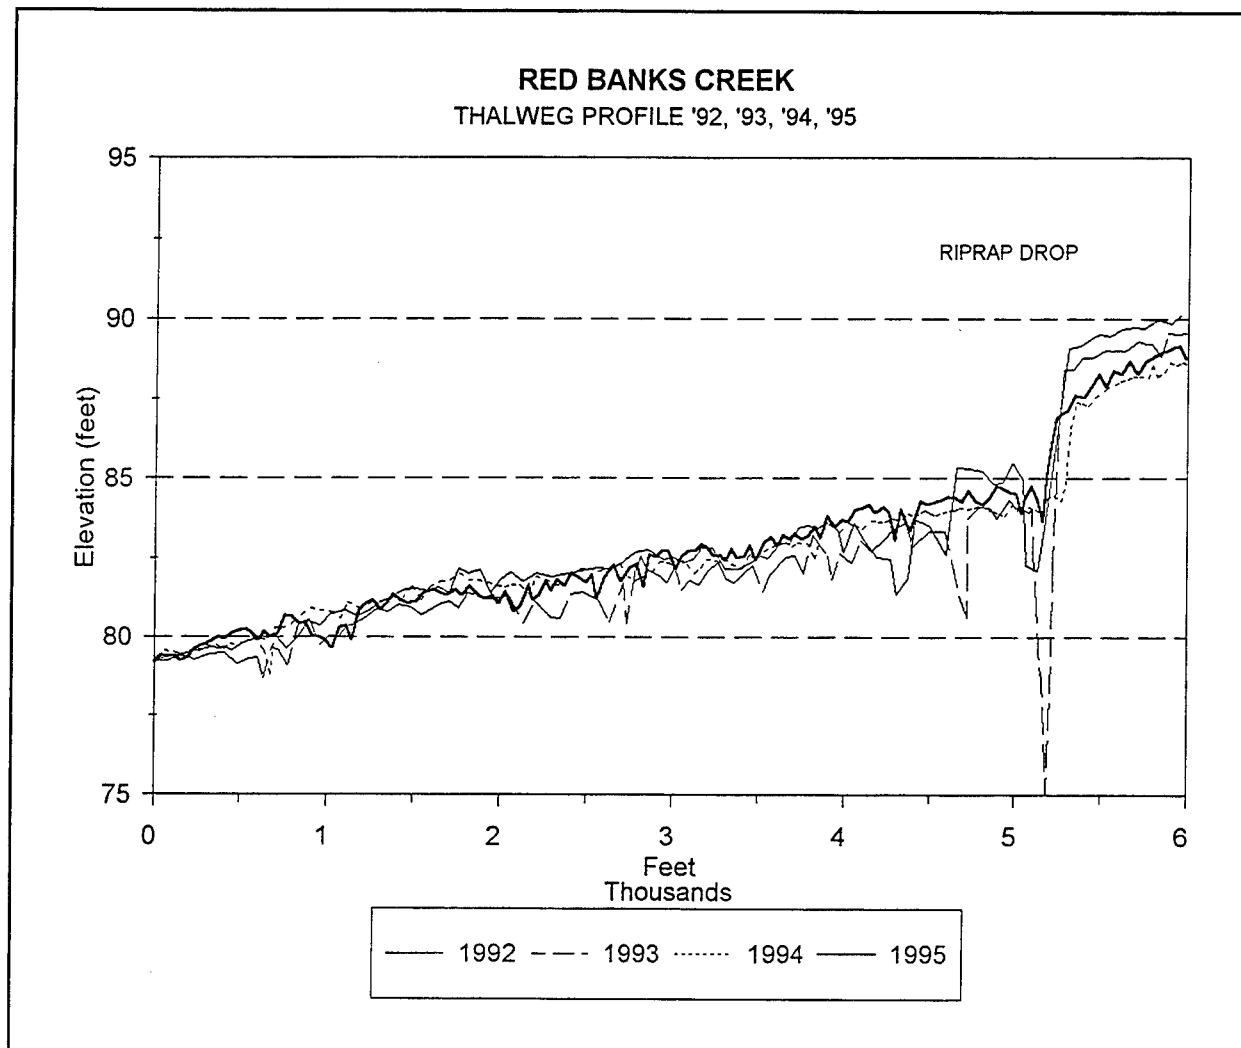
Figure 61. Thalweg profiles surveyed in 1992-1995

The impacts of the toe riprap and dikes for the first 1,000 ft upstream of the bridge have been as anticipated. Sediment has deposited between the riprap and the banks, and vegetation has taken hold. Willow trees are starting to grow on the right bank and sediment is continuing to deposit between the toe riprap and the toe of the slope. Based on thalweg surveys conducted in 1993, 1994, and 1995, there does not appear to be any conclusive evidence that the channel has started to scour as a result of the increasing bank roughness (Figure 61).

Figure 61 shows the thalweg profiles as surveyed in 1992, 1993, 1994, and 1995. The profile shows the channel reach from station 0+00 to 60+00, the same reach shown in Figure 62. Based on the thalweg surveys, there does not appear to have been any significant change in the thalweg profile over the past 4 years.

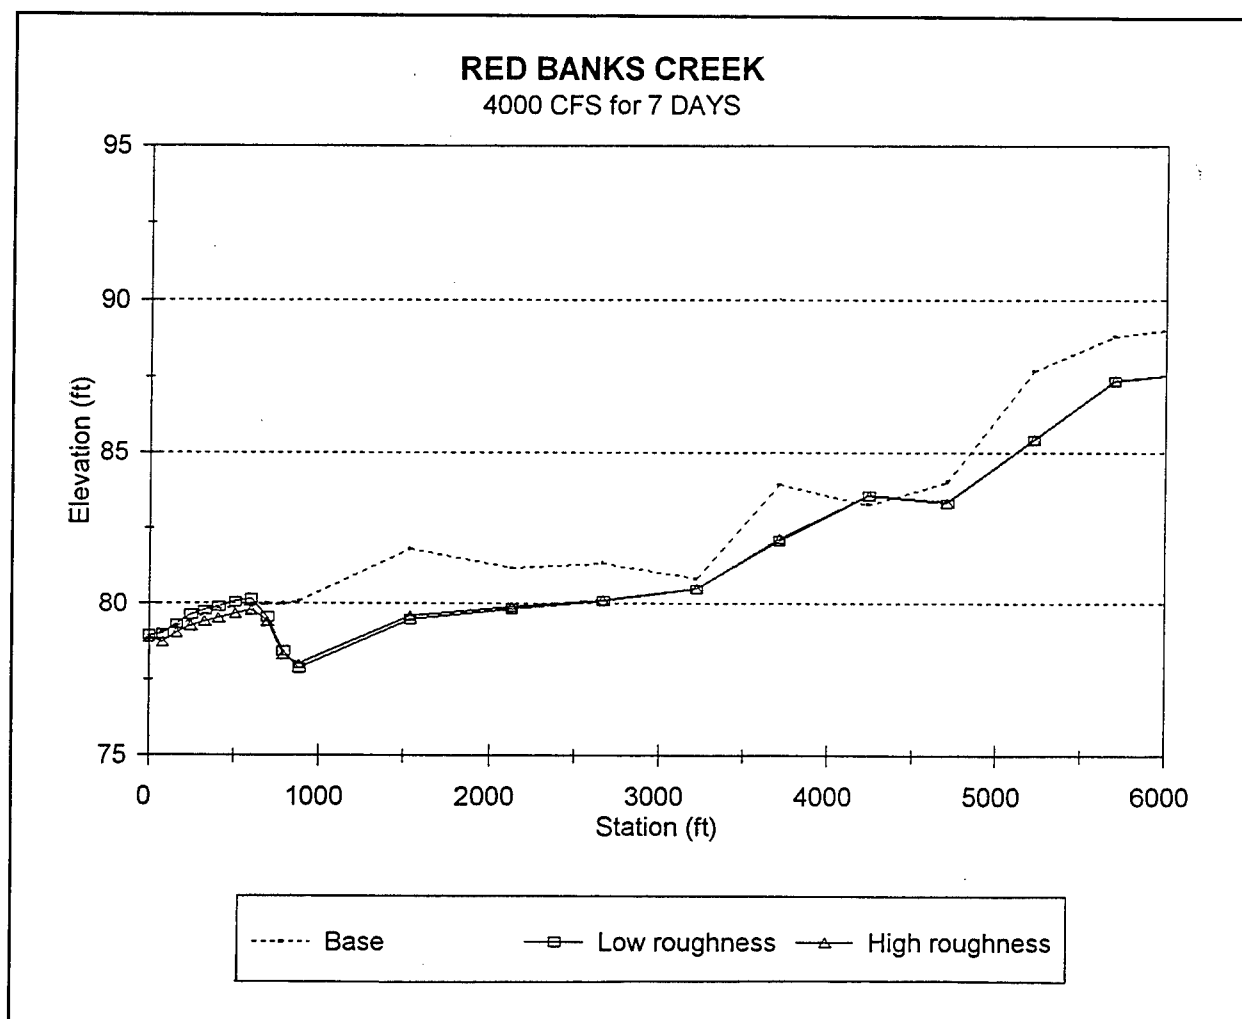
Figure 62. Comparison of predicted thalweg profiles with low and high bank roughness

The results of the simulation showed that the increase in bank roughness has a minimal impact on the predicted channel aggradation or degradation. Figure 62 shows the channel profile after 7 days of flow at 4,000 cfs. The bed profile prior to the simulation is shown along with the bed profile for the low bank roughness and the high bank roughness after the simulation. Only the downstream 6,000 ft of the channel are shown in Figure 62. The simulation shows approximately 1 to 2 ft of bed degradation between stations 5+00 and 20+00. This is due to the fact that the channel in general is narrower in this reach than it is between stations 0+00 and 5+00. The reduced channel width occurs naturally and is not the result of any channel stabilization measures. The model showed slight bed aggradation between stations 0+00 and 5+00 for the low bank roughness and no real change for the high bank roughness. The difference between the low and high bank roughness, however, is less than 1 ft. Considering that the 2-year event probably has a duration of less than 2 days, the difference can be considered negligible.

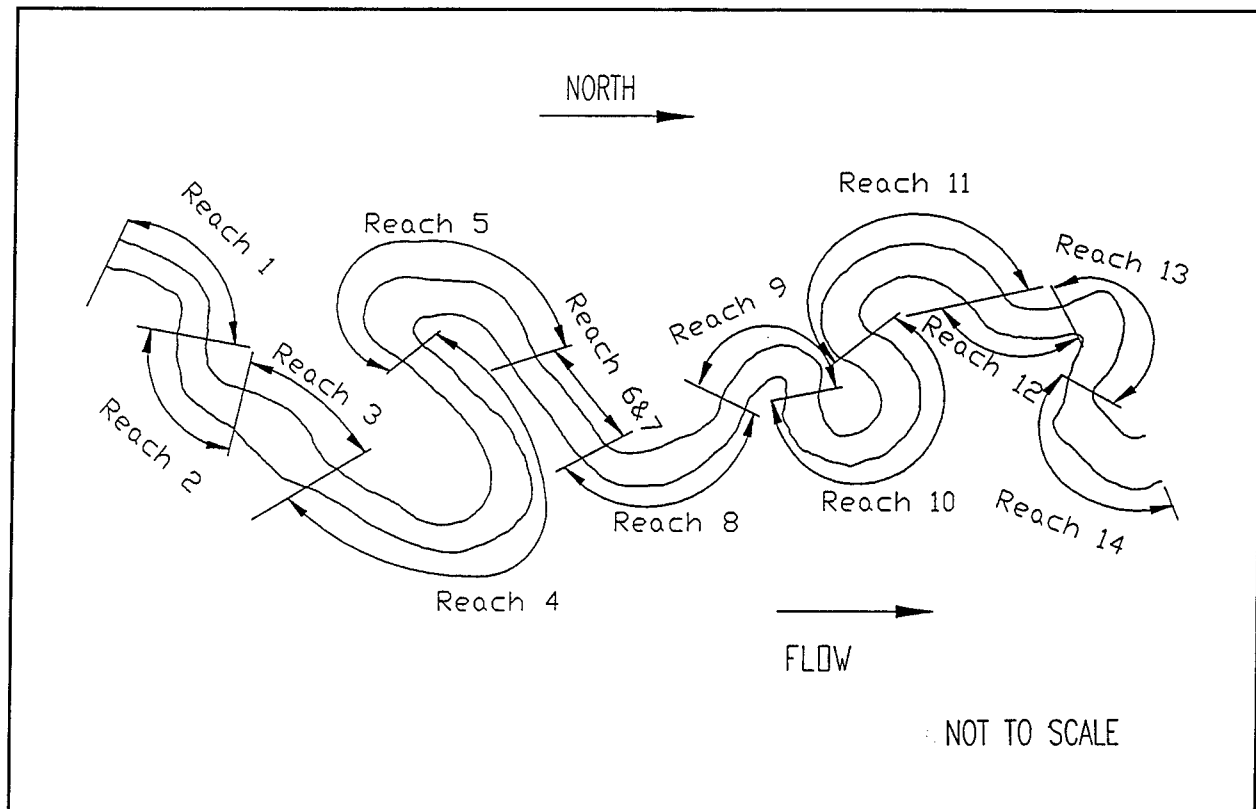
Figure 63. Harland Creek general planform

Harland Creek is tributary to Black Creek. The average width of Harland Creek is approximately 95 ft and average depth is approximately 6 ft; however, these dimensions vary significantly along the reach. The 2-year discharge is approximately 3,750 cfs. The channel has an actively meandering, sinuous planform, as shown in Figure 63. The significant sand and gravel transport through the reach is estimated to be approximately 8,700 tons per day at the 2-year discharge. The average sediment size (D_{50}) is 0.5 mm, including gravel up to approximately 4 cm.

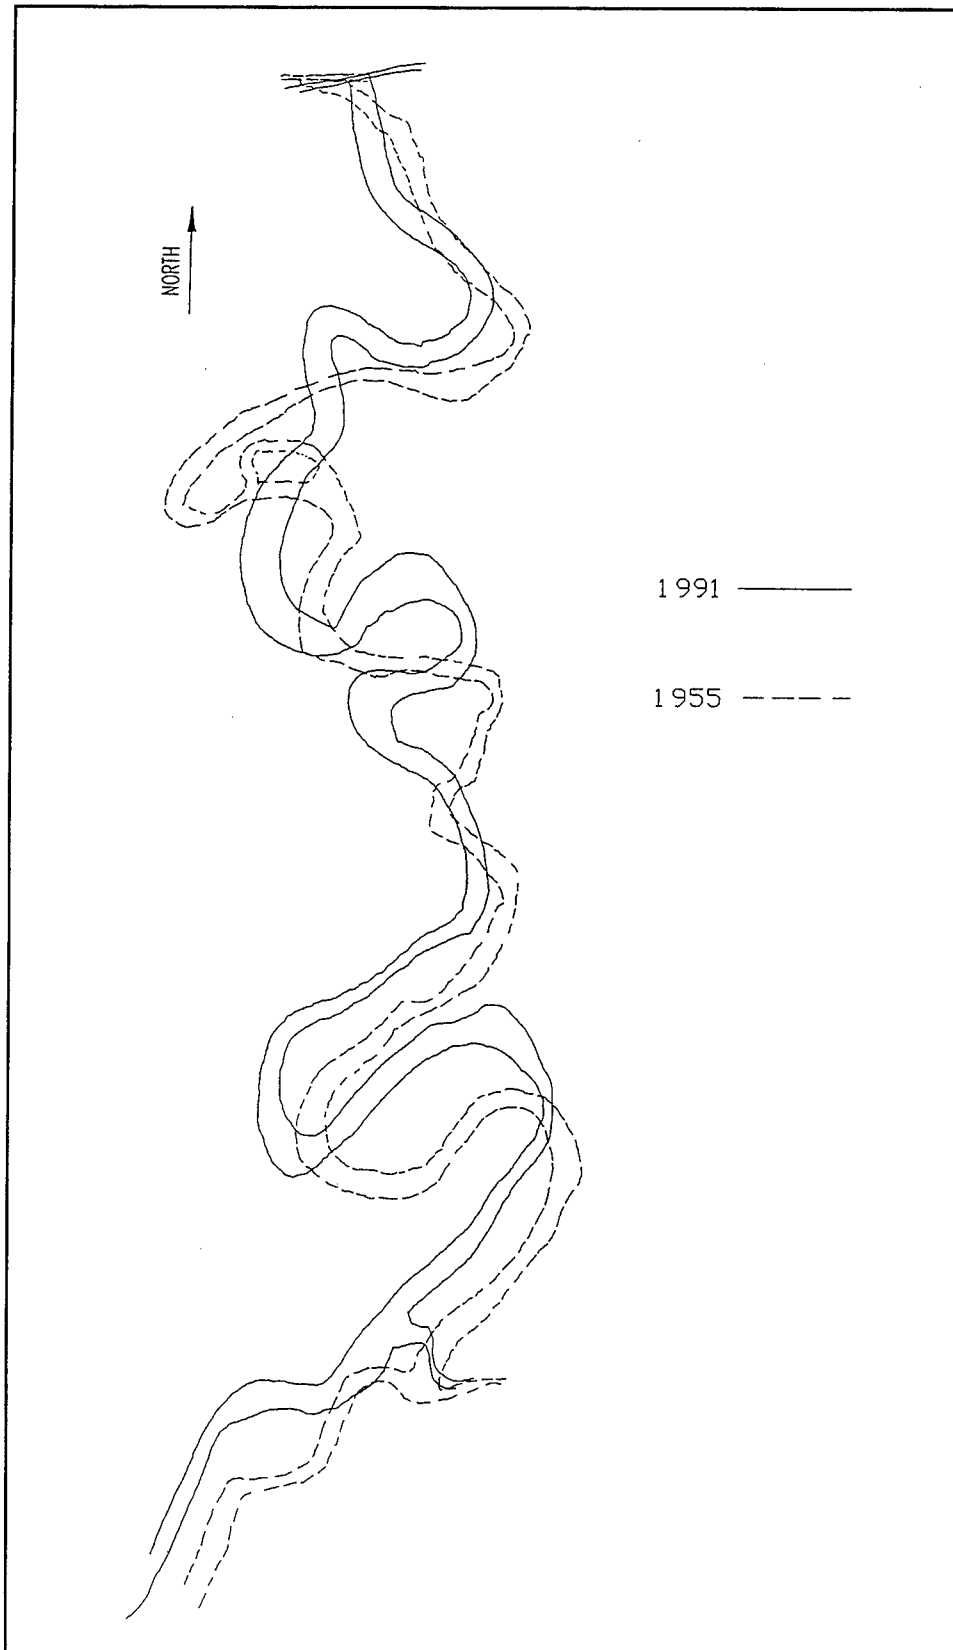
Figure 64. Harland Creek, bank line comparison from 1955 to 1991

Harland Creek has been an extremely active meandering channel as can be observed from the bank line comparison (Figure 64) made from four sets of aerial photographs dated 1955 to 1991. Based on measurements from the aerial photographs, the average annual bank migration rate is approximately 14 ft per year, or about 15 percent of the bendway channel width annually. To the landowner, this translates to movement of a full channel width in less than 7 years, approximately 12 acres of land loss per mile of stream.

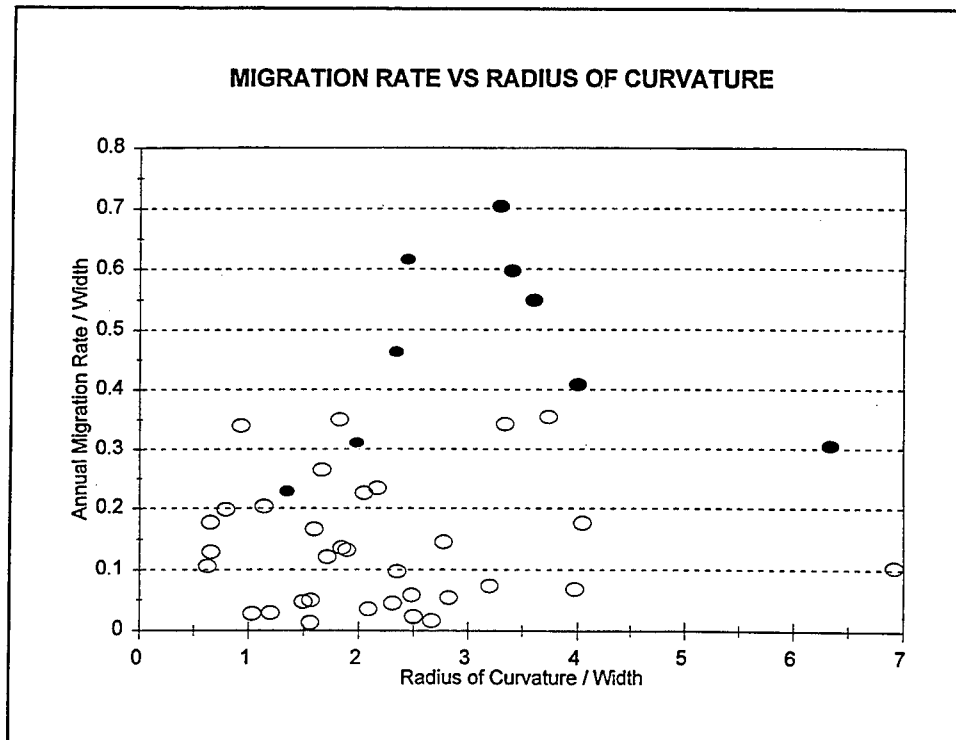
Figure 65. Harland Creek, bendway radius of curvature versus migration rate

Figure 65 is a plot of Harland Creek data showing the radius of curvature of the meander bends divided by the channel width on the x-axis, and the annual migration rate divided by the channel width on the y-axis. The dark, filled data points are representative of the upper envelope of data points for the Beaton River, British Columbia (Hickin and Nanson 1975). The envelope lines indicate that the maximum rate of channel bend migration occurs as the ratio of the radius of curvature to width (R_c/W) approaches a value of 3.0, or in a

broader range, for about 2.5 to 3.2. Bends in this range are rapidly altered to either a greater or less R_c/W , which have less dynamic rates of migration. Less than 20 percent of the Harland Creek data were found in the 2.5 to 3.2 range.
